# David Remi Home Inspections

## Property Inspection Report

Property address: **5275 Lynridge Dr,  
Yorba Linda CA, 92886**

Inspection date: **Thursday, October 03, 2013**

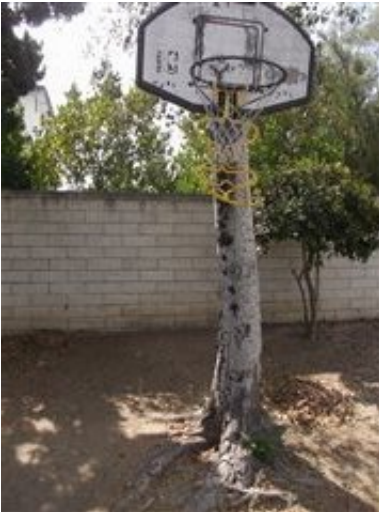
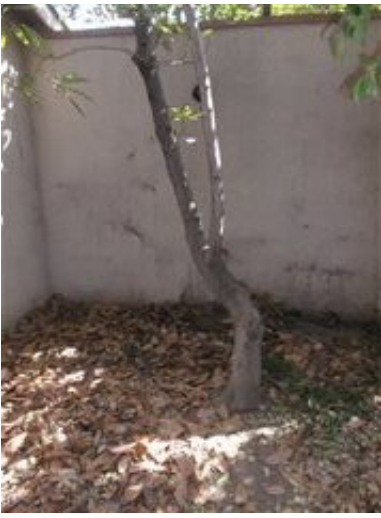
- 2) ⚒ One or more large tree roots were close to the foundation. Tree roots can cause significant structural damage to foundations, or may have already caused damage. Recommend that a qualified tree service contractor or certified arborist remove trees as necessary to prevent damage to foundations.

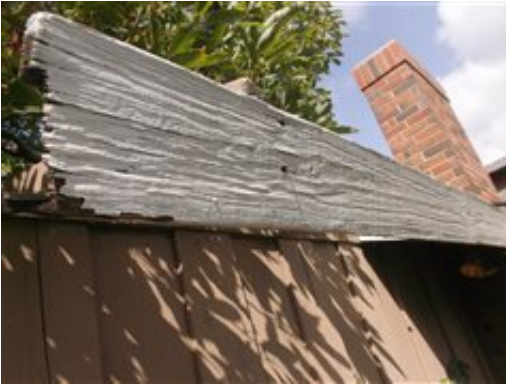
Fungal rot/ wood rot was found at one or more fascia, soffits, and or exposed beams. Recommend that a qualified person repair as necessary. All rotten wood should be replaced.

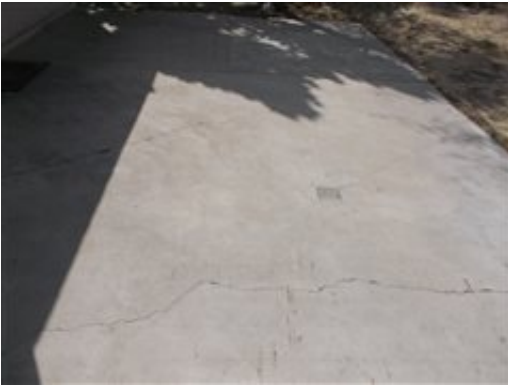
Cracks up to 1/8" on slab floor at rear section. Recommend sealing cracks to eliminate water intrusion and settling.

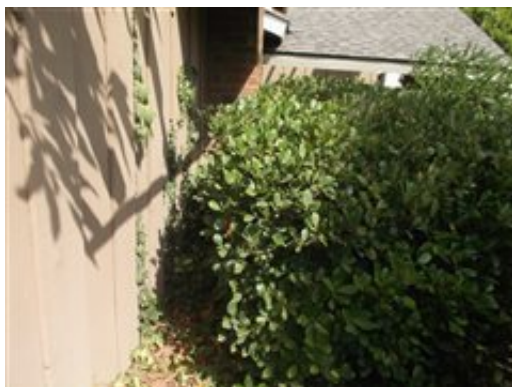
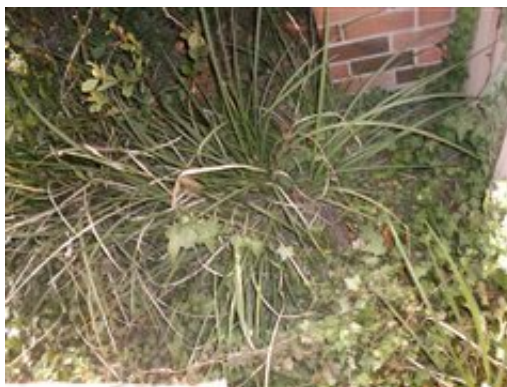
- 5) 🗝️ Vegetation such as trees, shrubs and/or vines was in contact with or close to the building exterior. Vegetation can serve as a pathway for wood-destroying insects and can retain moisture against the exterior after it rains. This is a conducive condition for wood-destroying organisms. Recommend pruning, moving or removing vegetation as necessary to maintain at least 6 inches of space between it and the building exterior. A 1-foot clearance is better.

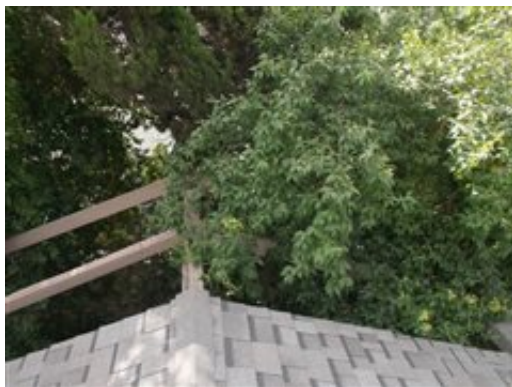
Photo 45

- 
- 7) 🗝️ Branches or bushes touching house or overhanging roof. Overhanging tree limbs should be pruned to avoid debris on roof.

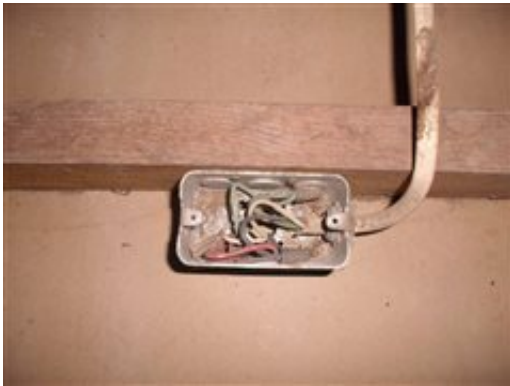
**Photo 75**

Open/ missing electrical splices is fire hazard. In accordance with accepted electrical practice, all splices must be inside an approved electrical box with a cover, and this box must be attached to the framing of the house and accessible. These boxes are either metal or plastic.

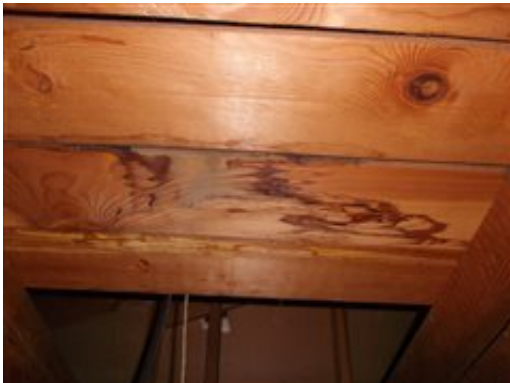
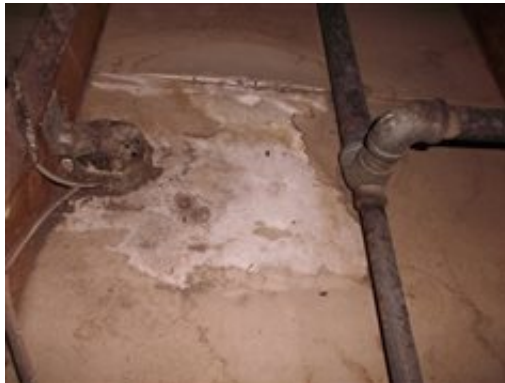
**Photo 76**

Water stains on underside of roofing in multiple areas. The inspector is unable to determine if current leaks. Recommend further evaluation and repair by a licensed contractor.

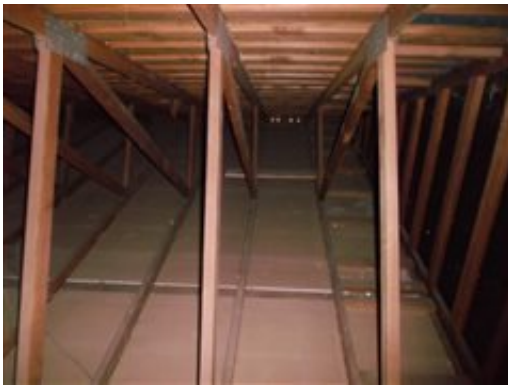
**Photo 73**

No ceiling insulation was installed in the attic. Recommend that a qualified contractor install insulation for better energy efficiency and per standard building practices (typically with an R rating of R-38).

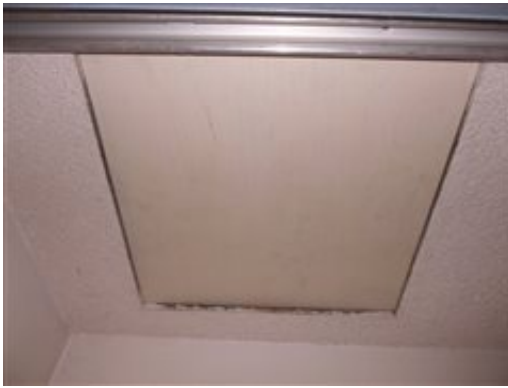
**Photo 72**

One or more attic access hatches or doors were not insulated. Weatherstripping was also missing or substandard. Recommend installing weatherstripping and insulation per current standards at hatches or doors for better energy efficiency. For more information, visit:

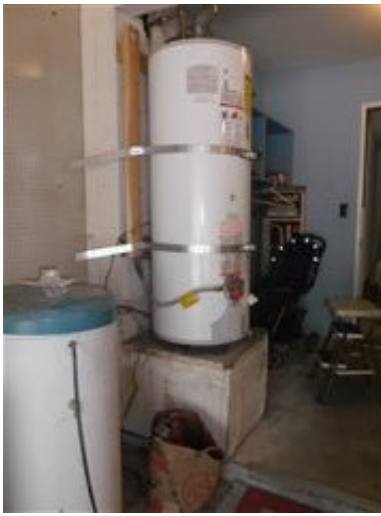
**Photo 60**

The water heater is subject to damage from vehicles because no protective barrier was installed in front of it. This is a potential safety hazard. A qualified contractor should install a barrier per standard building practices. For example, a steel post or specially made wood partition anchored in the concrete slab floor.

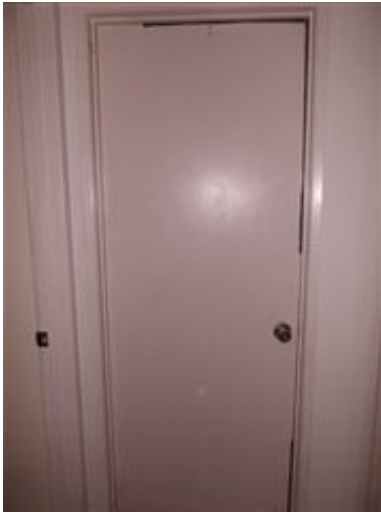
**Photo 70**

Weatherstripping around or at the base of the door between the garage and the house was missing, damaged. House to garage doors should prevent fire and fumes from spreading from the garage to the house. Weatherstripping should form a seal around this door. This is a potential safety hazard. Recommend that a qualified person replace or install weatherstripping as necessary.

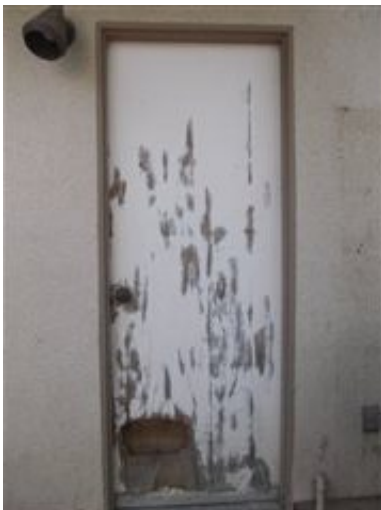
## Photo 17

Garage side door is damaged and should be replaced.

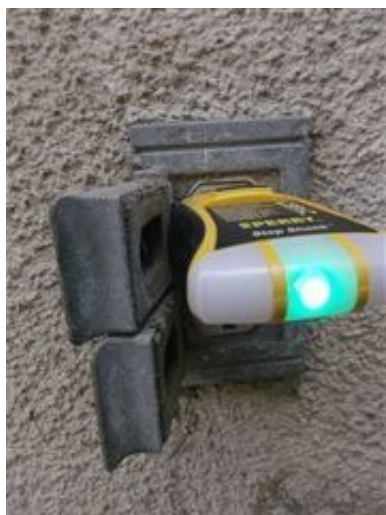
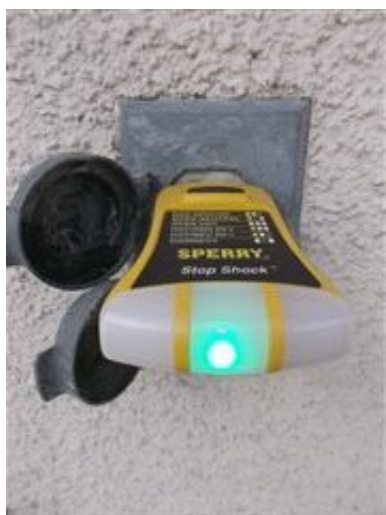
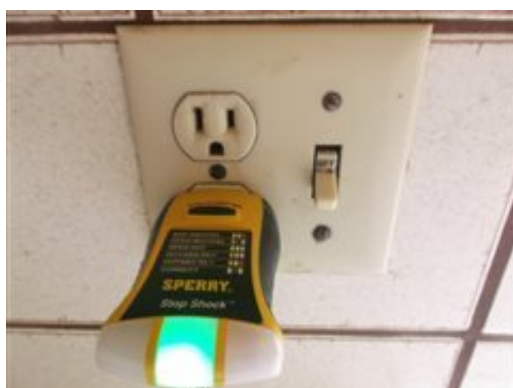
17) 🛠️ 🔍 One or more electric receptacles (outlets) at the kitchen, bathroom(s), garage, exterior had no visible ground fault circuit interrupter (GFCI) protection, or the inspector was unable to determine if GFCI protection was present. If not GFCI-protected, receptacles in wet areas pose a shock hazard. Recommend that a qualified electrician evaluate and install GFCI protection if necessary and per standard building practices. General guidelines for GFCI-protected receptacles include the following locations:

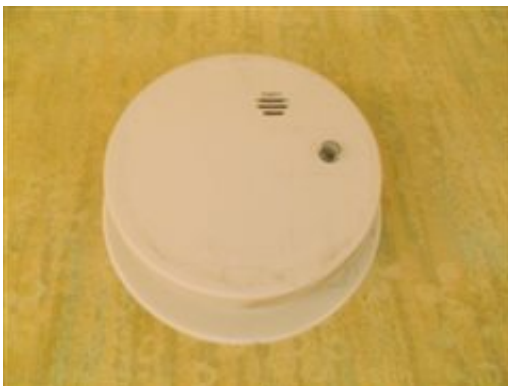
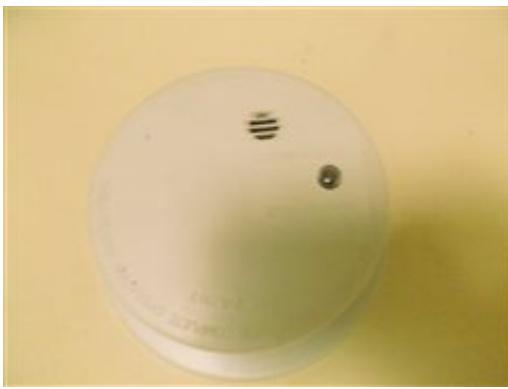
**18) +🔧** One or more smoke alarms were damaged, or missing components. Smoke alarms should be replaced as necessary. For more information, visit:  
<http://www.cpsc.gov/cpscpub/pubs/559.pdf>

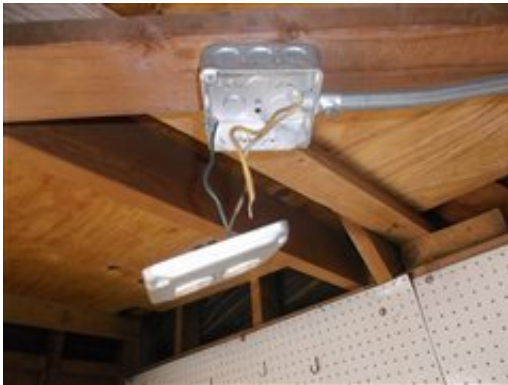
**Photo 59**

**19) +** One or more cover plates for switches, receptacles (outlets) or junction boxes were missing or broken. These plates are intended to contain fire and prevent electric shock from occurring due to exposed wires. Recommend that a qualified person install cover plates where necessary.

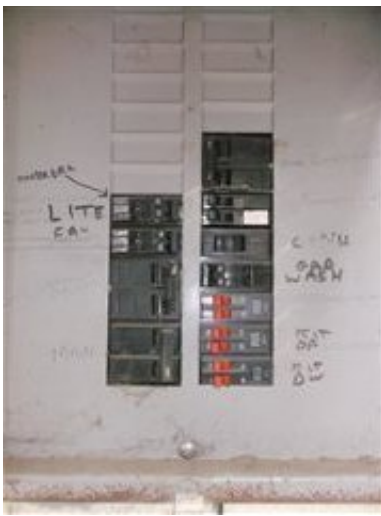
**Photo 37**

**21) +** Breakers are not professionally labeled for emergency identification. Recommend that a qualified electrician label the breakers.

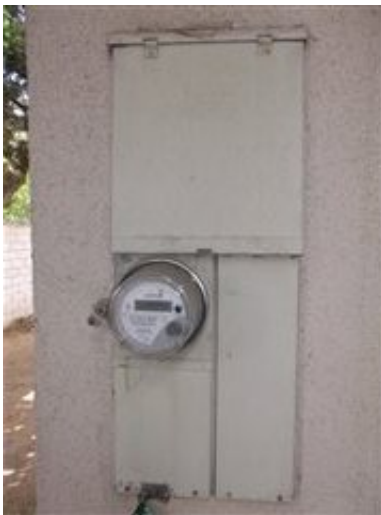
**Photo 36**

The electric service to this property appeared to be rated at substantially less than 200 amps and may be inadequate. Depending on the client's needs, recommend consulting with a qualified electrician about upgrading to a 200 amp service. Note that the electric service's rating is based on the lowest rating for the meter base, the service conductors, the main service panel and the main disconnect switch. One or more of these components may need replacing to upgrade.

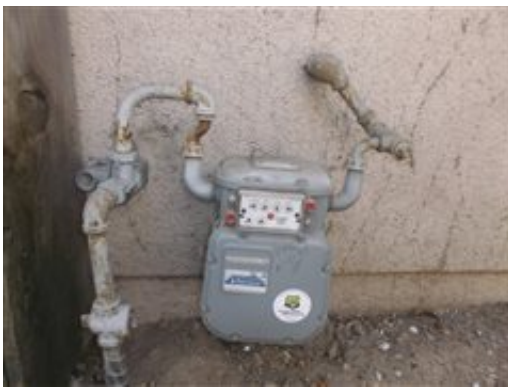
**Photo 15**

Seismic shutoff valve is recommended to be installed at Gas meter.

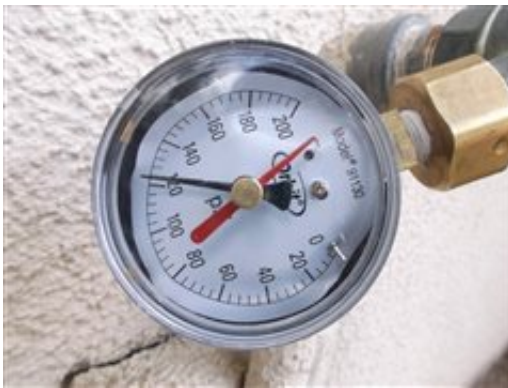
**Photo 97**

**24)** 🔧🔍 The water supply pressure was greater than 80 pounds per square inch (PSI). Pressures above 80 PSI may void warranties for some appliances such as water heaters or washing machines. Flexible supply lines to washing machines are likely to burst with higher pressures. 40-80 PSI is considered the normal range for water pressure in a home, and most plumbers recommend 50-60 PSI . Typically, the pressure cannot be regulated at the water meter. Recommend that a qualified plumber evaluate and make modifications to reduce the pressure to below 80 PSI . Installing a pressure reducing valve on the main service pipe is a common solution to this problem. If one exists, then it should be adjusted, repaired or replaced as necessary to maintain lower pressures. Note that installing a pressure reducing valve creates a "closed system," which may require installing an expansion tank at the water heater if one is not already installed.

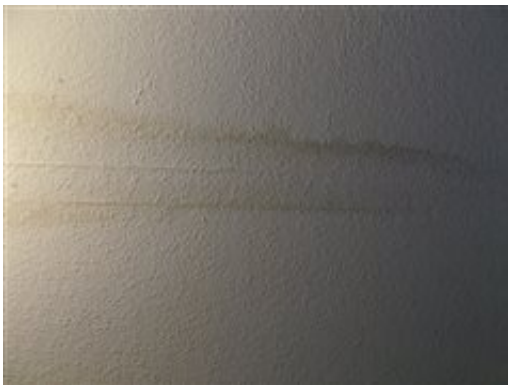
**Photo 66**

**25)** 🔧🔍 Water stains in ceiling section at laundry room. \*See attic section\*.

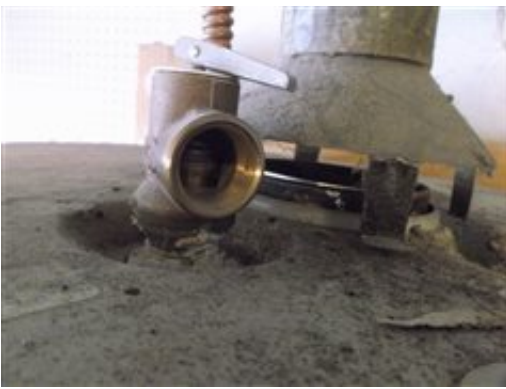
**Photo 65**

No drain line was installed for the temperature-pressure relief valve. This is a potential safety hazard due to the risk of scalding if someone is standing next to the water heater when the valve opens. Recommend that a qualified plumber install a drain line per standard building practices.

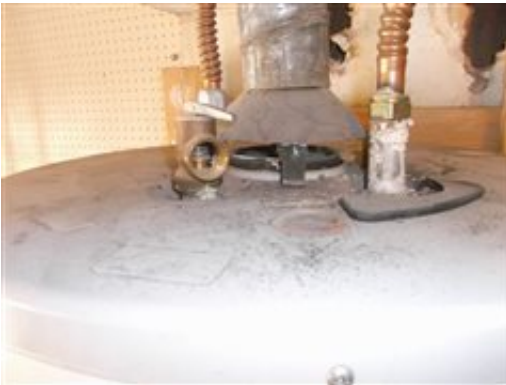
**Photo 63**

**31)** 🔧🔍 Corrosion or rust was found at the supply pipes or fittings. This can indicate past leaks, or that leaks are likely to occur in the future. Recommend that a qualified plumber evaluate and replace components or make repairs as necessary.

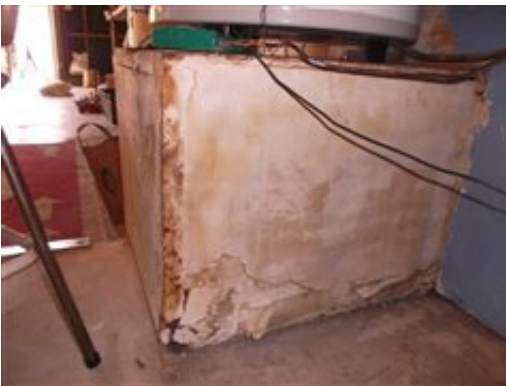
**Photo 91**

**32)** 🔧🔍 Water stains were found below the water heater. This may be a sign that the water heater is failing, or be a sign of a past leak.

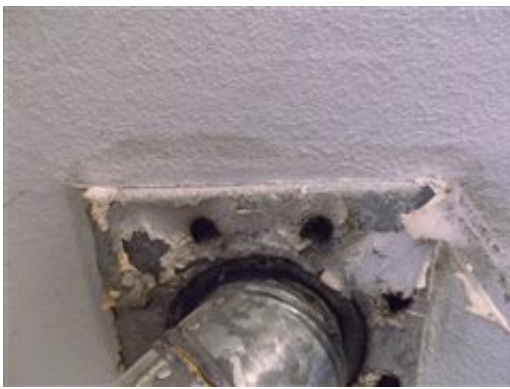
**Photo 68**

**33)** 🔧🔍 Water stains in ceiling around water heater exhaust vent. \*See attic section\*.

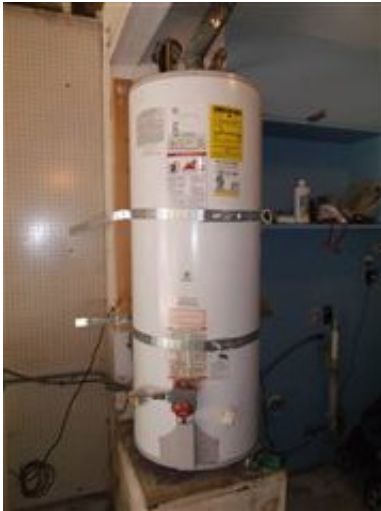
**Photo 62**

The estimated useful life for most water heaters is 8-12 years. The inspector was unable to determine the age of the water heater due to the manufacturer's label being obscured, no serial number being visible, or the serial number not clearly indicating the age. The client should be aware that this water heater may be near, at or beyond its useful life and may need replacing at any time. Recommend attempting to determine the water heater's age.

If found to be near, at or beyond its useful lifespan, recommend budgeting for a replacement in the near future, or considering replacement now before any leaks occur. The client should be aware that significant flooding can occur if the water heater does fail. If not replaced now, consider having a qualified person install a catch pan and drain or a water alarm to help prevent damage if water does leak.

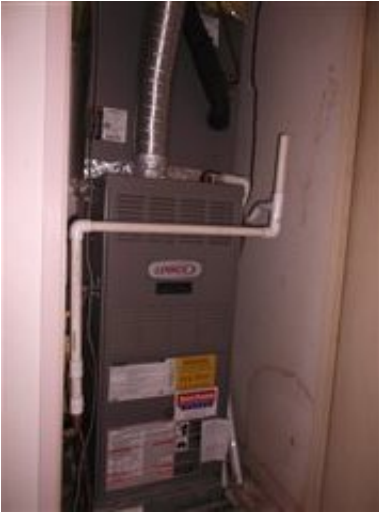
**Photo 92**

The last service date of the gas or oil-fired forced air furnace appeared to be more than 1 year ago, or the inspector was unable to determine the last service date. Recommend that a qualified HVAC contractor inspect, clean, and service this system, and make repairs if necessary. For safety reasons, and because this system is fueled by gas or oil, this servicing should be performed annually in the future. Any needed repairs noted in this report should be brought to the attention of the HVAC contractor when it's serviced. For more information visit:

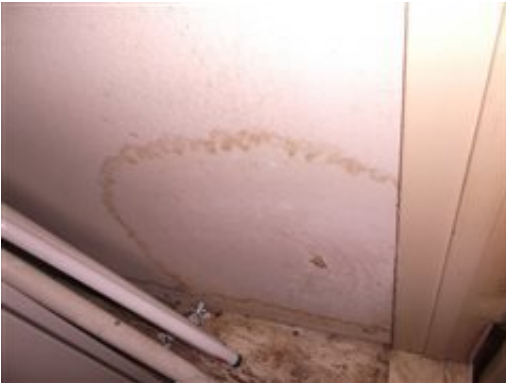
**Photo 93**

Water stains on furnace closet wall. The inspector was unable to determine source of leak or if active leak. Recommend further evaluation and repair if necessary by a licensed contractor.

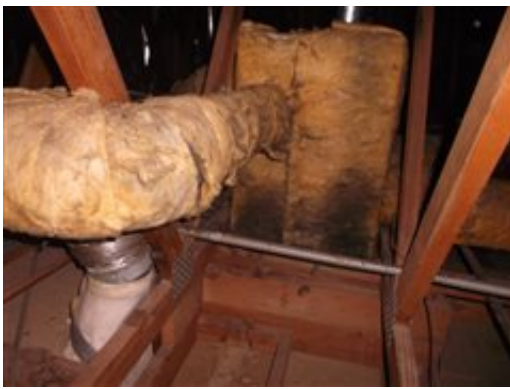
**Photo 85**

One or flex ducts used for heating or cooling were disconnected. This may result in reduced energy efficiency due to restricted flow. Recommend that a qualified person make repairs as necessary.

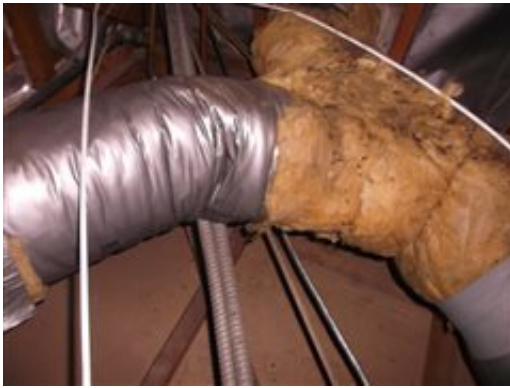
**Photo 90**

One or more flex duct used for heating or cooling had tears in the plastic covering. Moisture may infiltrate the duct's insulation and result in reduced energy efficiency. Recommend that a qualified person make permanent repairs as necessary. For example, by applying foil tape, or replacing duct sections if damage is significant or if insulation is wet.

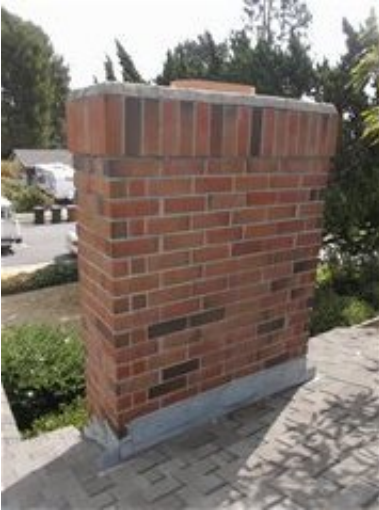
**Photo 41**

No spark screen or rain cap was installed at one or more chimney flue terminations. Spark screens reduce the chance of embers exiting the flue and causing fires. They also prevent wildlife (e.g. birds, rodents, raccoons) from entering flues. Rain caps prevent water from entering flues, mixing with combustion deposits and creating caustic chemicals which can corrode flues. They also prevent damage to masonry from freeze-thaw cycles and prevent metal components (e.g. dampers, metal firebox liners) from rusting. Recommend that a qualified person install rain caps with spark screens per standard building practices where missing.

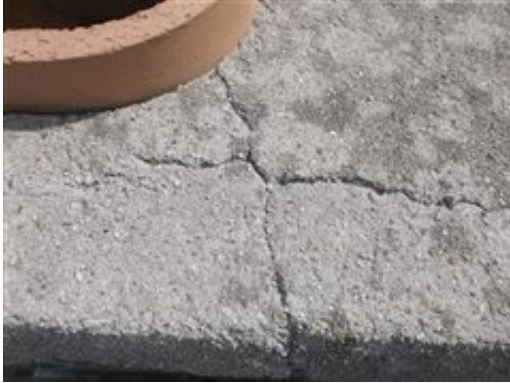
**Photo 43**

One or more masonry chimney crowns were cracked, deteriorated. Crowns are meant to keep water off of the chimney structure and prevent damage from freeze-thaw cycles. Chimney crowns are commonly constructed by mounding concrete or mortar on the top chimney surface, however this is substandard. A properly constructed chimney crown should:

Recommend that a qualified contractor repair or replace crowns as necessary, and per standard building practices.

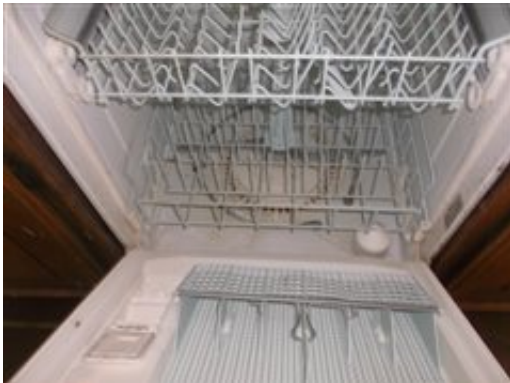
**Photo 118**

The dishwasher was malfunctioning. Recommend that a qualified specialist evaluate and repair or replace as necessary.

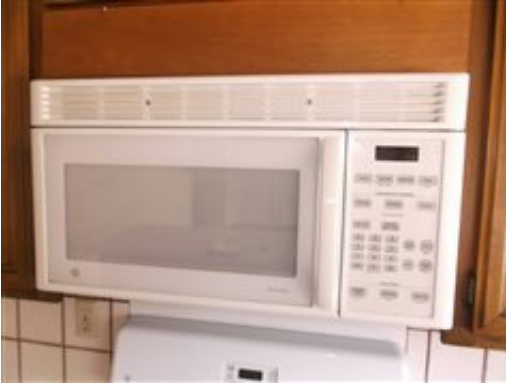
**Photo 106**

- 
- 44) 🛠️ The digital display on the microwave oven was damaged, unreadable. Recommend that a qualified person repair as necessary.

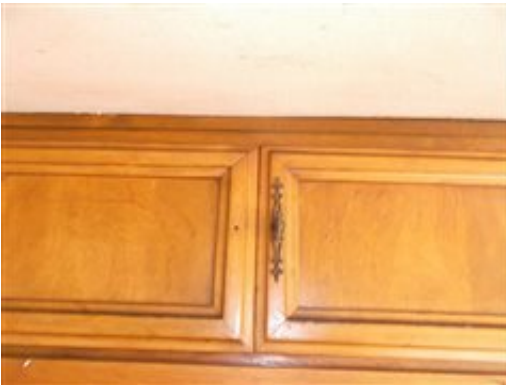
**Photo 105**

- 
- 45) 🛠️ Cabinet hardware such as pulls were missing at one or more cabinet drawers, doors or turntables. Recommend that a qualified person repair as necessary.

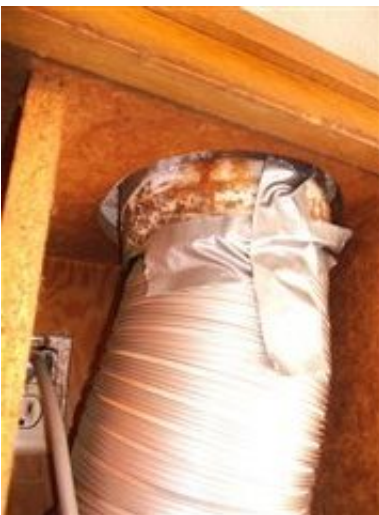
**Photo 107**

- 
- 46) 🛠️ Gaps in exhaust hood duct may cause the fan to recirculate exhaust air back into the kitchen when operated.

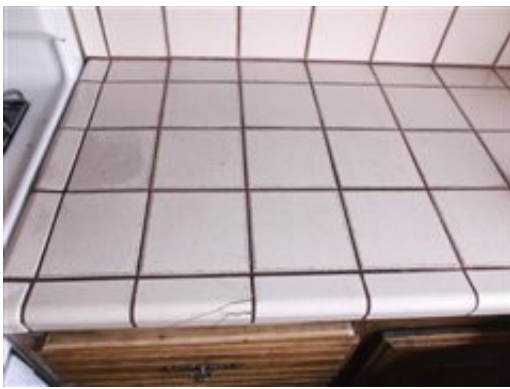
**Photo 109**

- 
- 47) 🛠️ Cracks on tile in multiple areas (counter).

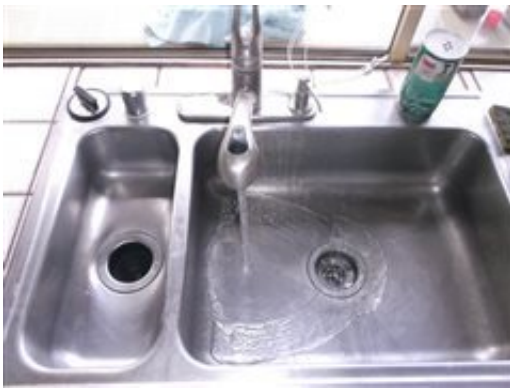
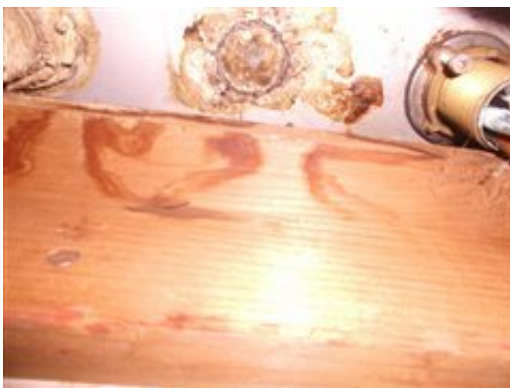
48) 🛠 Sink faucet is badly damaged at base/ bottom.

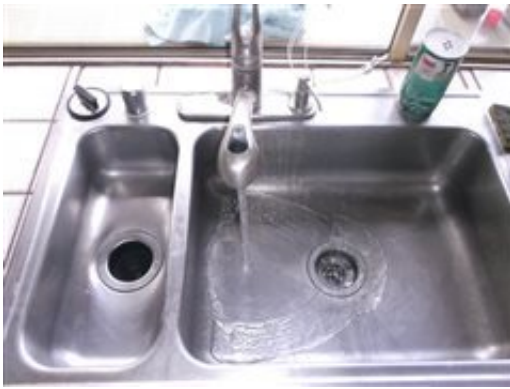
**Photo 114**

49) 🛠 Gaps, no caulk, or substandard caulking were found around the sink. Water may penetrate these

areas and cause damage. Recommend that a qualified person repair as necessary. For example, by installing caulk.

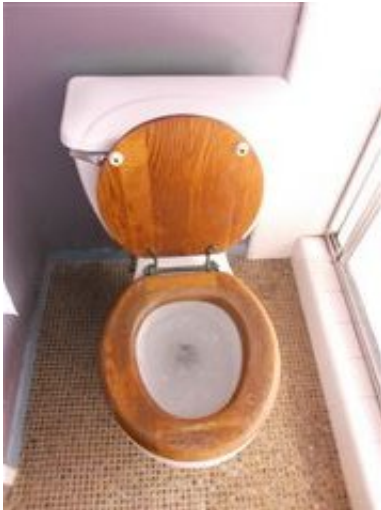
**Photo 136**

The toilet at location(s) #B was loose where it attached to the floor. Leaks can occur. Flooring, the subfloor or areas below may get damaged. Recommend that a qualified contractor remove the toilet(s) for further evaluation and repair if necessary. A new wax ring should be installed and toilet(s) should be securely anchored to the floor to prevent movement and leaking.

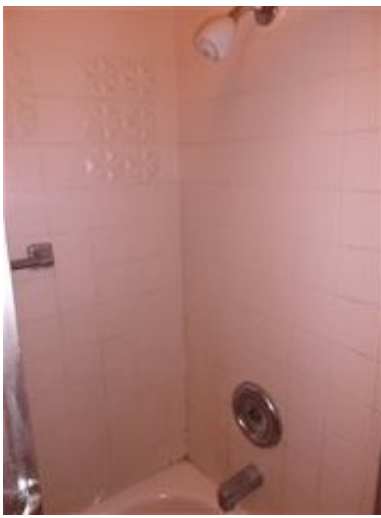
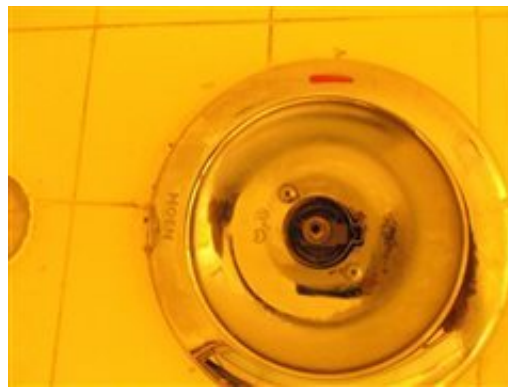
One or more shower handles at location(s) #A were missing. Recommend that a qualified person repair or replace handles as necessary.

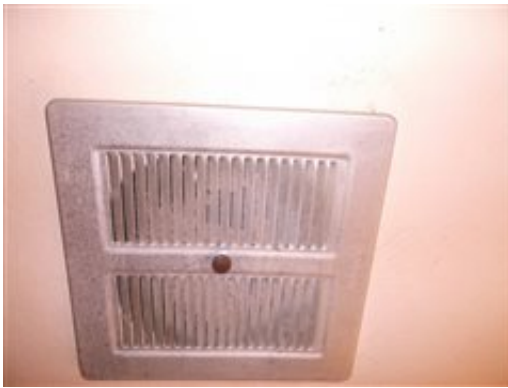
**Photo 120**

The exhaust fan (s) at location(s) #A was weak or slow. Moisture may accumulate and result in mold, bacteria or fungal growth. Recommend that a qualified person clean, repair or replace fans as necessary.

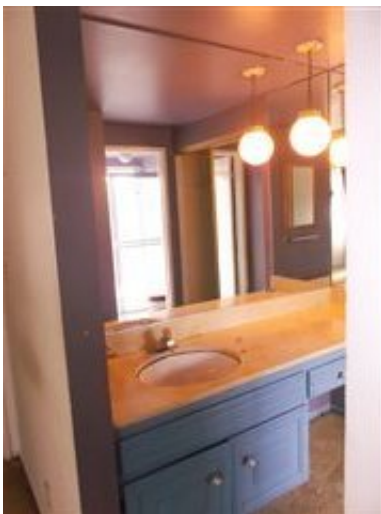
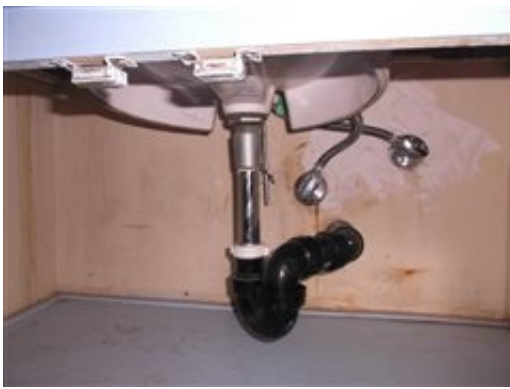
Gaps, no caulk, or substandard caulking were found between countertops and backsplashes, around the sink at location(s) #B. Water can penetrate these areas and cause damage. Recommend that a qualified person repair as necessary. For example, by installing or replacing caulk.

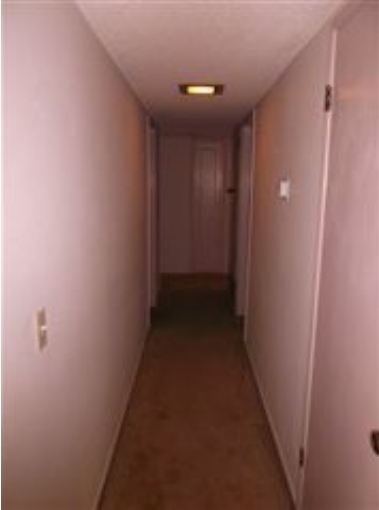
**Photo 153**

Carpeting in one or more areas was loose and posed a trip hazard. Recommend that a qualified contractor repair as necessary. For example, by stretching or replacing carpeting.

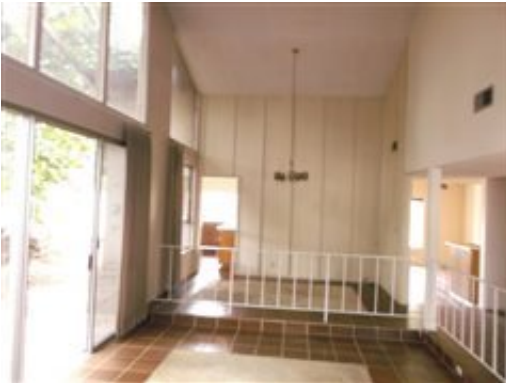
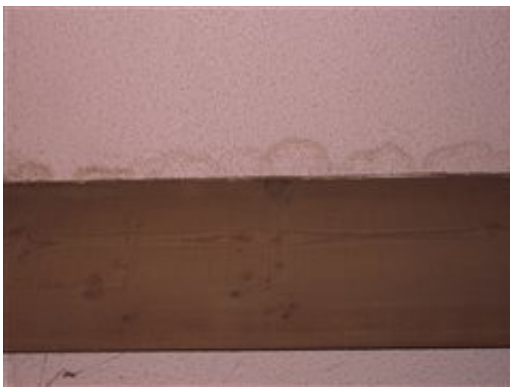
Stains were found in one or more ceiling areas. The inspector was unable to determine if an active leak exists (e.g. recent dry weather, inaccessible height).

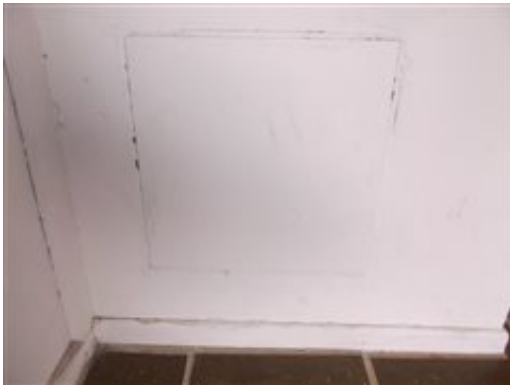
**Photo 149**

**58)** 🔧🔍 Water stains on trim at the dining area. The stains may be due to an active leak from the bathtub at location # A. Recommend further evaluation and repair after the shower handle as been installed.

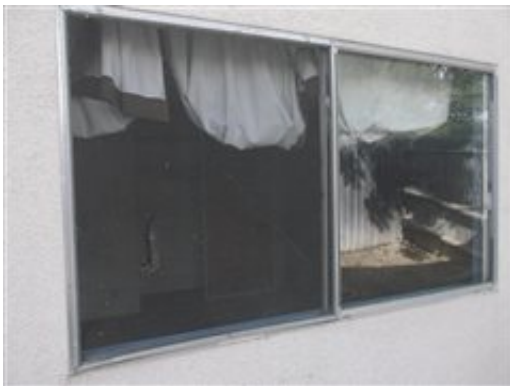
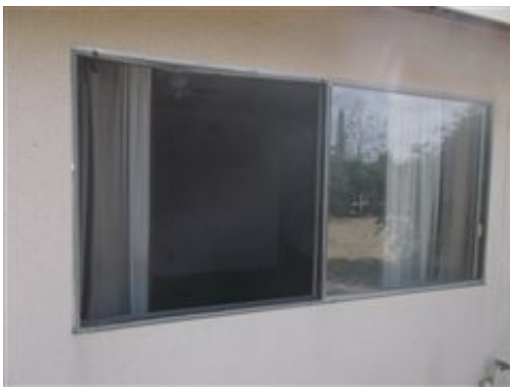
**59)** 🔧 One or more window screens were damaged or deteriorated. These window(s) may not provide ventilation during months when insects are active. Recommend replacing window screens as necessary.

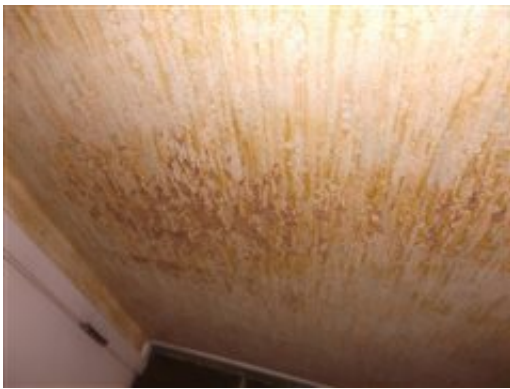
**Photo 157**

Interior room (s) wallpaper damaged in places.

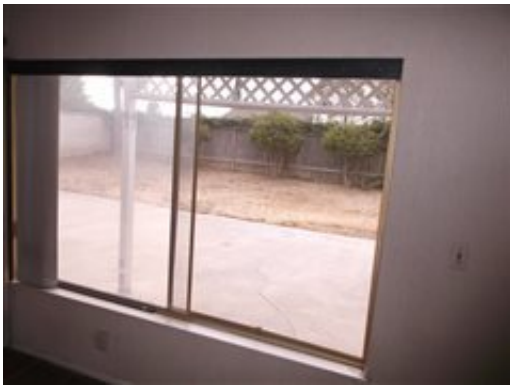
**Photo 151**

Condensation/ and or water penetration in sliding glass window at the dining area is evidence of seal failure. Have a qualified professional repair as necessary.

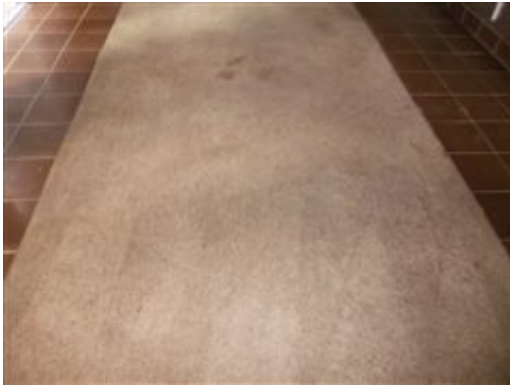
**Photo 142**

**62)** 🧹 Carpeting in one or more areas was significantly stained or soiled. Recommend having carpeting professionally cleaned as necessary.

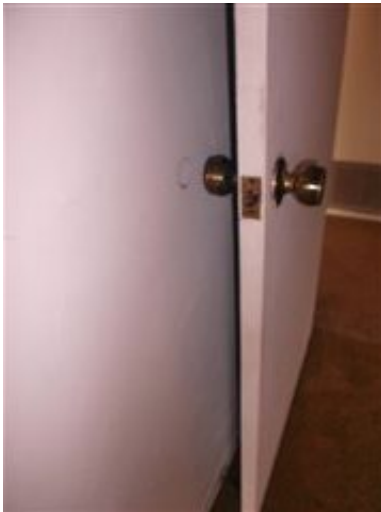
**Photo 164**

**63)** ✓ Door stops are recommended at all interior doors in order to prevent damage to the interior walls.
