**WOOD DESTROYING PESTS AND ORGANISMS INSPECTION REPORT**

| Building No.<br>5275 | Street<br>LYNRIDGE DRIVE | City<br>YORBA LINDA | Zip<br>92886 | Date of Inspection<br>10/04/13 | Number of Pages<br>5 |
| GENERAL DESCRIPTION: A ONE STORY STUCCO RESIDENCE WITH A COMPOSITION ROOF, SLAB FOUNDATION AND A TWO CAR ATTACHED GARAGE. (UNFURNISHED AND UNOCCUPIED) | | | | Inspection Tag Posted:<br>GARAGE<br><br>Other Tags Posted:<br>NONE | |

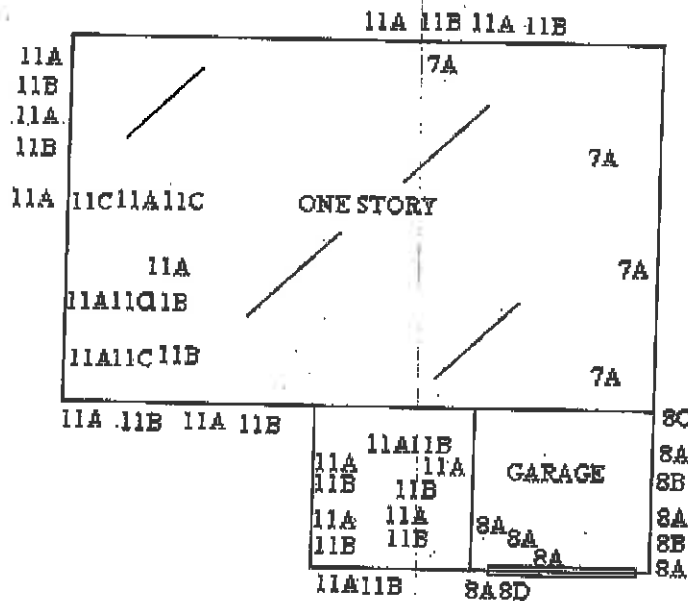
Diagram Not To Scale

07A - FINDING - EVIDENCE OF DRYWOOD TERMITES NOTED AT RIDGEPOLE AND ROOF JOISTS.  
SEE 7A ON THE DIAGRAM.

08A - FINDING - EVIDENCE OF DRYWOOD TERMITES NOTED AT THE FRAMING IN GARAGE.  
SEE 8A ON THE DIAGRAM.

08B - FINDING - EVIDENCE OF DRYWOOD TERMITE DAMAGE NOTED AT 2X6 JAMB, 2X6 FASCIA AND 1X12  
SIDING. SEE 8B ON THE DIAGRAM.

08C - FINDING - MOISTURE DAMAGE NOTED AT 30 INCH MAN DOOR. SEE 8C ON THE DIAGRAM.

11A - FINDING - EVIDENCE OF DRYWOOD TERMITES NOTED AT EAVES, RAFTER TAILS, FASCIA AND  
HEADER. SEE 11A ON THE DIAGRAM.

11B - FINDING - EVIDENCE OF DRYWOOD TERMITE DAMAGE NOTED AT 2X6 FASCIA, 2X8 FASCIA, 4X6  
FASCIA, 1X12 SIDING PLYWOOD SIDING AND 2X6 RAFTERS. SEE 11B ON THE DIAGRAM.

11C - FINDING - EVIDENCE OF DRYWOOD TERMITE DAMAGE NOTED AT BEAM AND RAFTERS LEFT SIDE OF  
HOUSE. SEE 11C ON THE DIAGRAM.

RECOMMENDATION - FUMIGATE PREMISES WITH VIKANE GAS (SULFURYL FLORIDE). SEAL STRUCTURE  
AND REMOVE SEALS. READY FOR OCCUPANCY. REMOVE OR COVER EVIDENCE. SECTION 1

RECOMMENDATION - REPAIR AS NECESSARY. WOOD DAMAGE BEING REPAIRED BY THIS COMPANY MAY  
LEAD INTO INACCESSIBLE AREAS WHERE FURTHER DAMAGE MAY OCCUR AND A SUPPLEMENTAL REPORT  
WILL BE FILED WITH RECOMMENDATIONS AND COSTS FOR CORRECTIONS.\*\*\*PLEASE SEE NOTE ABOVE\*\*\*  
SECTION 1

RECOMMENDATION - INSTALL NEW 30 INCH DOOR KIT. SECTION 1

RECOMMENDATION - REMOVE DAMAGE AS NEEDED. SECTION 1
