# David Remi Home Inspections

## Property Inspection Report

Property address: **5275 Lynridge Dr,  
Yorba Linda CA, 92886**

Inspection date: **Thursday, October 03, 2013**

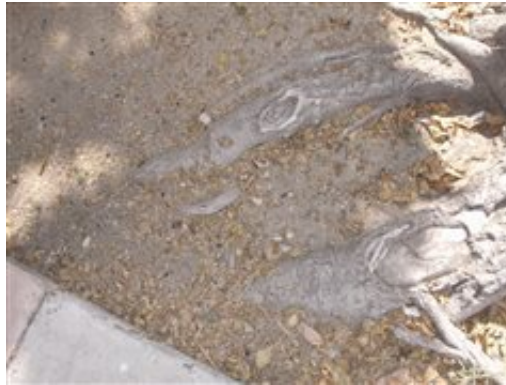
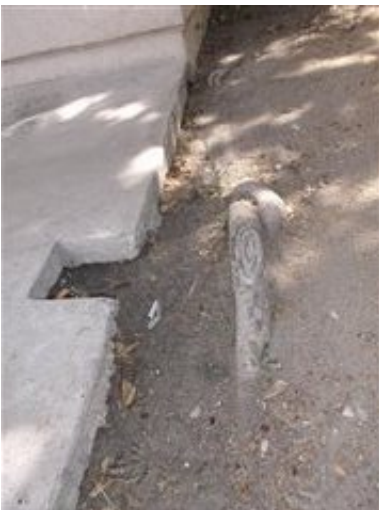
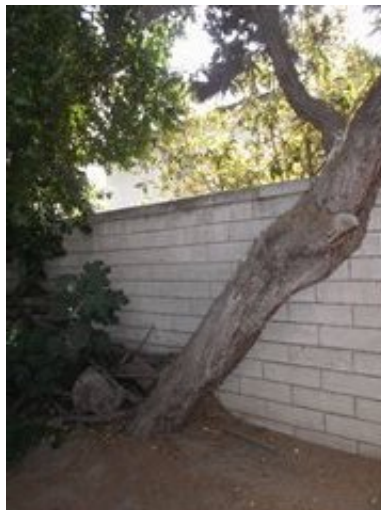
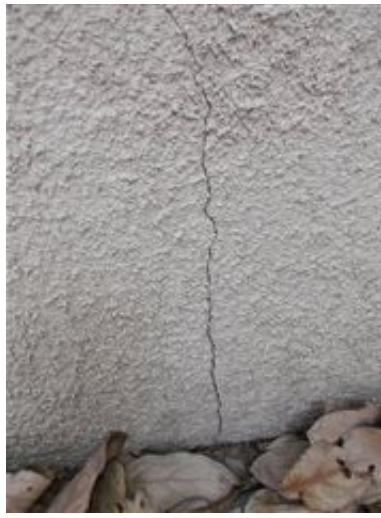
- 2) ⚒ One or more large tree roots were close to the foundation. Tree roots can cause significant structural damage to foundations, or may have already caused damage. Recommend that a qualified tree service contractor or certified arborist remove trees as necessary to prevent damage to foundations.

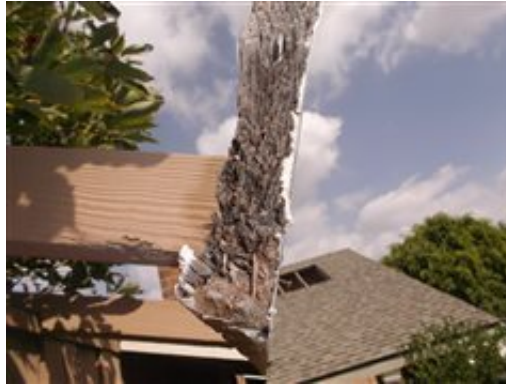
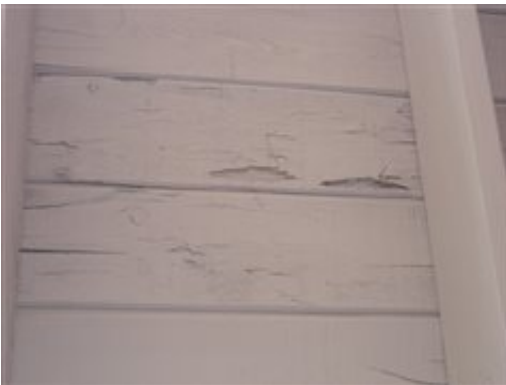
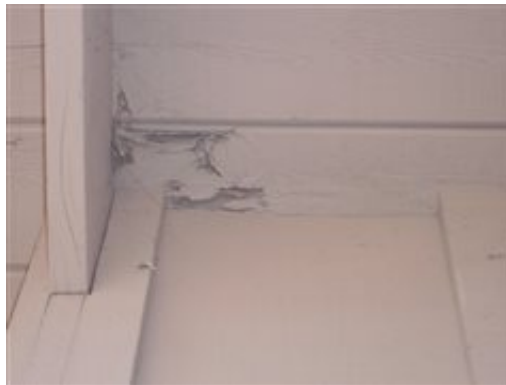
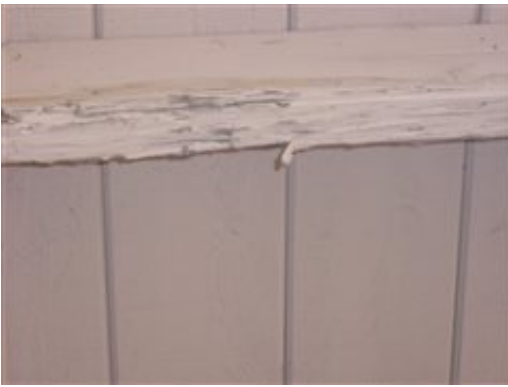
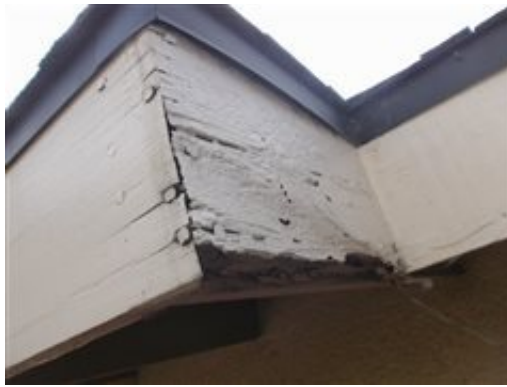
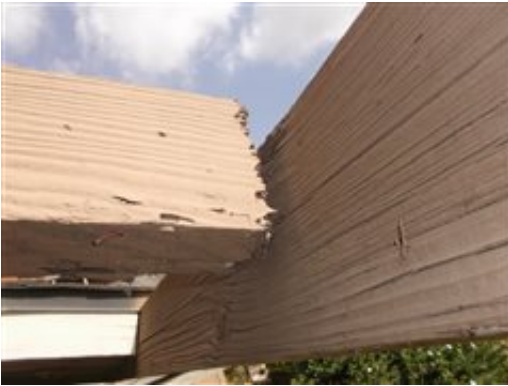
Fungal rot/ wood rot was found at one or more fascia, soffits, and or exposed beams. Recommend that a qualified person repair as necessary. All rotten wood should be replaced.

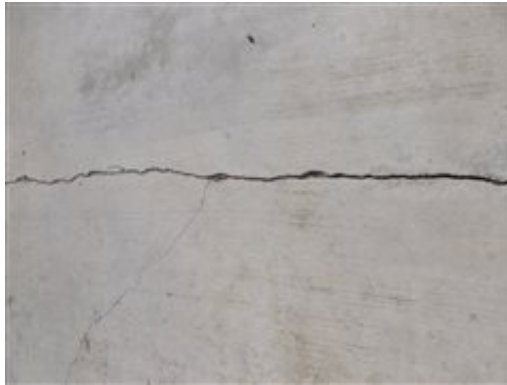
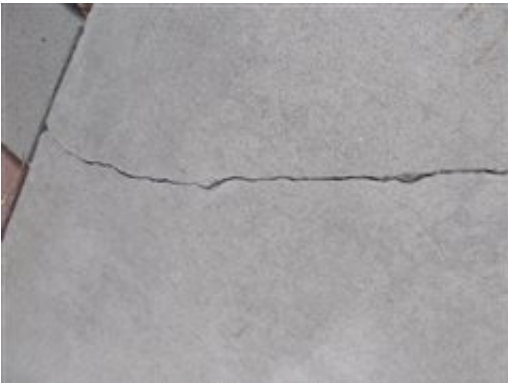
Cracks up to 1/8" on slab floor at rear section. Recommend sealing cracks to eliminate water intrusion and settling.

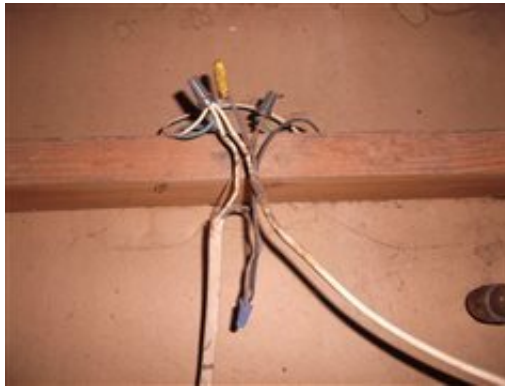
Open/ missing electrical splices is fire hazard. In accordance with accepted electrical practice, all splices must be inside an approved electrical box with a cover, and this box must be attached to the framing of the house and accessible. These boxes are either metal or plastic.

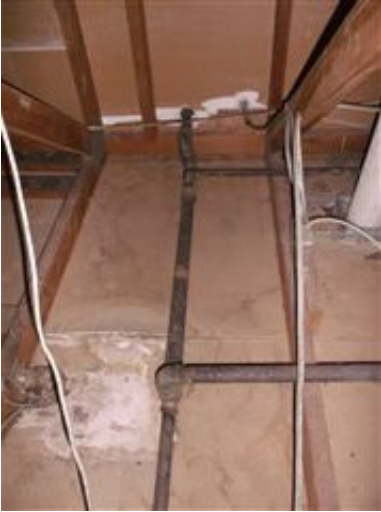
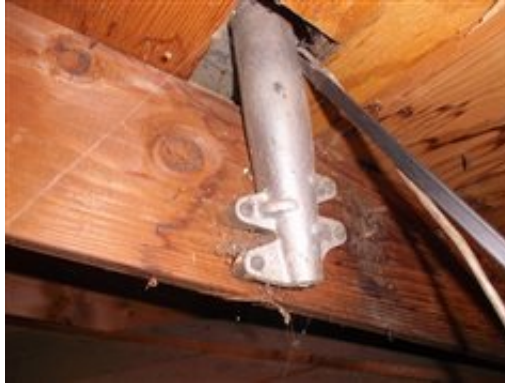
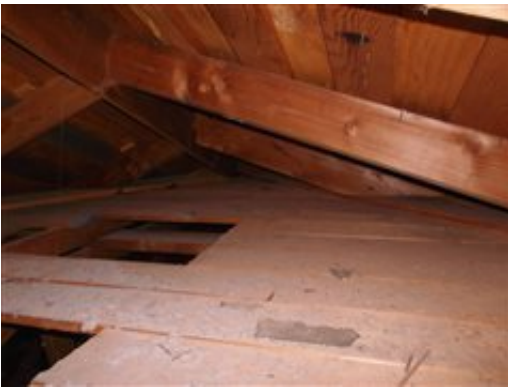
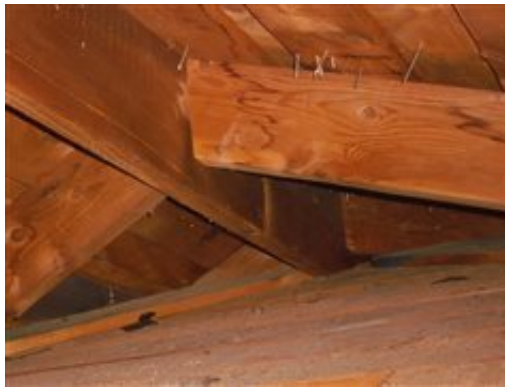
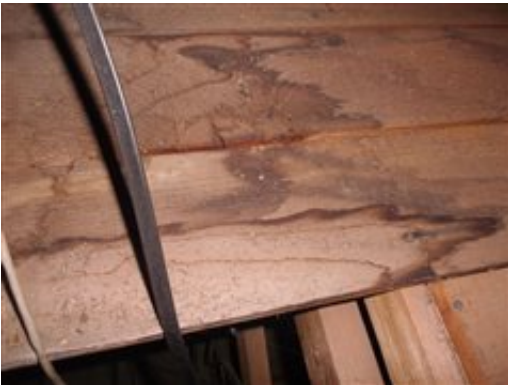
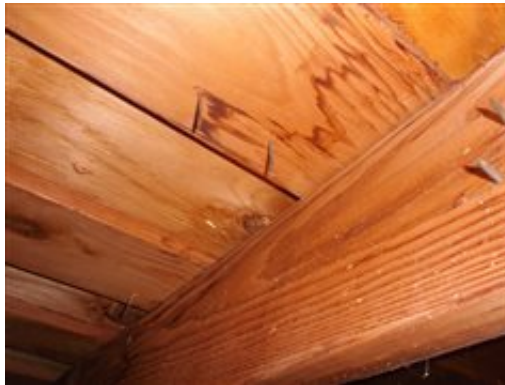
Water stains on underside of roofing in multiple areas. The inspector is unable to determine if current leaks. Recommend further evaluation and repair by a licensed contractor.

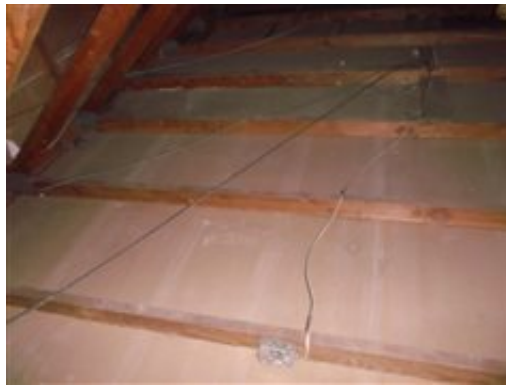
No ceiling insulation was installed in the attic. Recommend that a qualified contractor install insulation for better energy efficiency and per standard building practices (typically with an R rating of R-38).

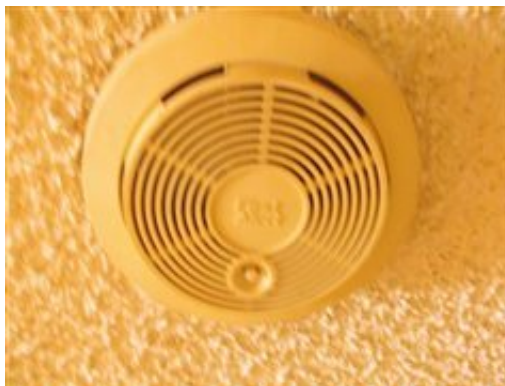
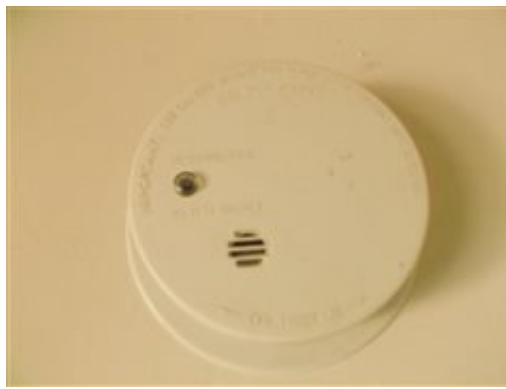
**18) +🔧** One or more smoke alarms were damaged, or missing components. Smoke alarms should be replaced as necessary. For more information, visit:  
<http://www.cpsc.gov/cpscpub/pubs/559.pdf>

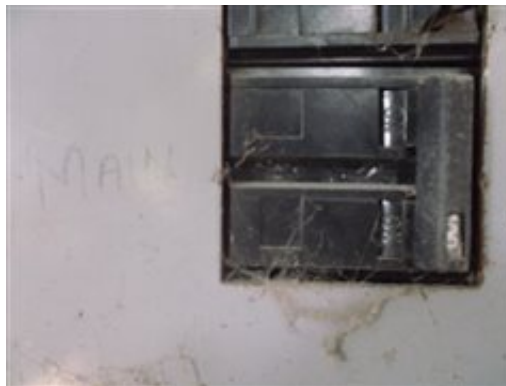
**Photo 38**

The electric service to this property appeared to be rated at substantially less than 200 amps and may be inadequate. Depending on the client's needs, recommend consulting with a qualified electrician about upgrading to a 200 amp service. Note that the electric service's rating is based on the lowest rating for the meter base, the service conductors, the main service panel and the main disconnect switch. One or more of these components may need replacing to upgrade.

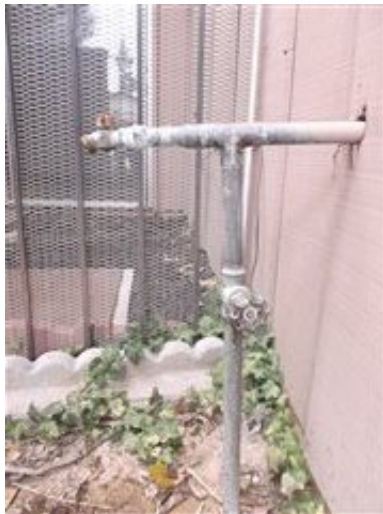
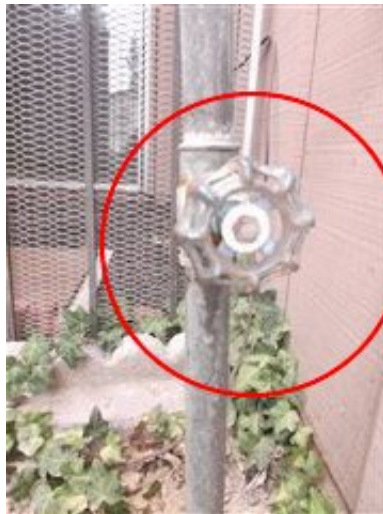
**26)** 🔧 The main water shut-off valve handle was inoperable. It is especially important to be able to reliably operate the main water shut-off valve in an emergency, such as when a supply pipe bursts.

Recommend that a qualified plumber repair as necessary.

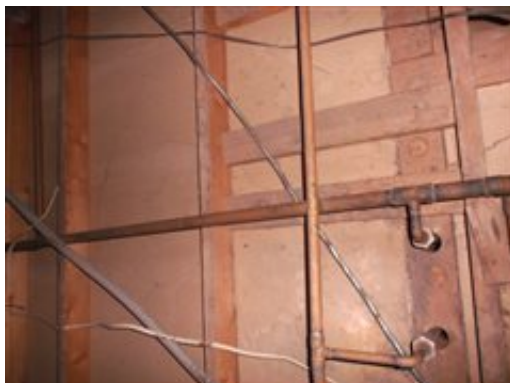
**Photo 84**

Visible plumbing in attic

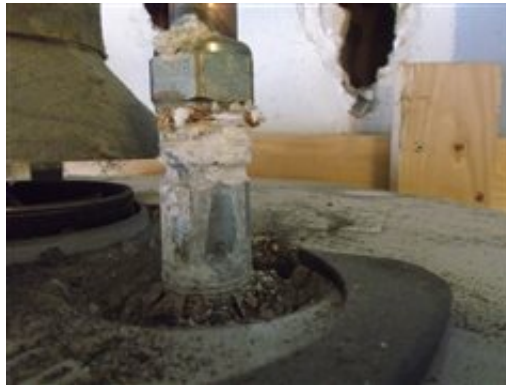
**Photo 64**

**31)** 🔧🔍 Corrosion or rust was found at the supply pipes or fittings. This can indicate past leaks, or that leaks are likely to occur in the future. Recommend that a qualified plumber evaluate and replace components or make repairs as necessary.

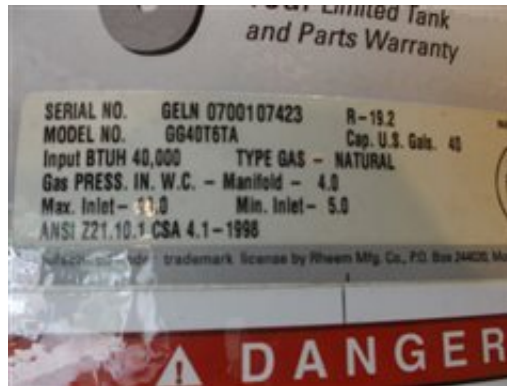
**Photo 69**

The estimated useful life for most water heaters is 8-12 years. The inspector was unable to determine the age of the water heater due to the manufacturer's label being obscured, no serial number being visible, or the serial number not clearly indicating the age. The client should be aware that this water heater may be near, at or beyond its useful life and may need replacing at any time. Recommend attempting to determine the water heater's age.

If found to be near, at or beyond its useful lifespan, recommend budgeting for a replacement in the near future, or considering replacement now before any leaks occur. The client should be aware that significant flooding can occur if the water heater does fail. If not replaced now, consider having a qualified person install a catch pan and drain or a water alarm to help prevent damage if water does leak.

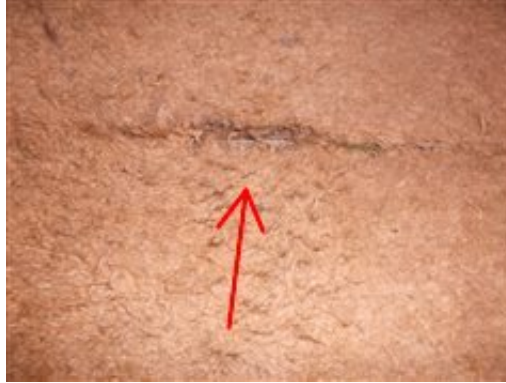
**Photo 153**

Carpeting in one or more areas was loose and posed a trip hazard. Recommend that a qualified contractor repair as necessary. For example, by stretching or replacing carpeting.

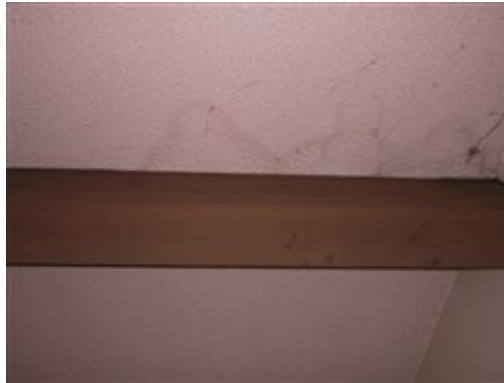
**Photo 141**

Stains were found in one or more ceiling areas. The inspector was unable to determine if an active leak exists (e.g. recent dry weather, inaccessible height).

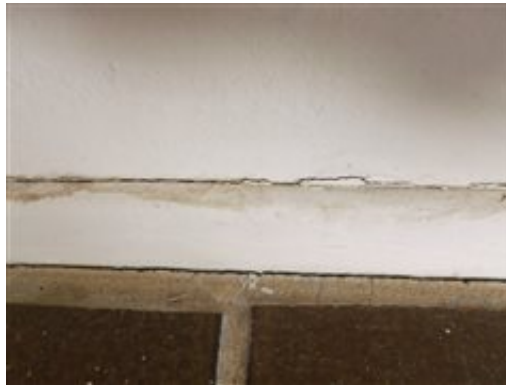
**Photo 149**

**58)** 🔧🔍 Water stains on trim at the dining area. The stains may be due to an active leak from the bathtub at location # A. Recommend further evaluation and repair after the shower handle as been installed.

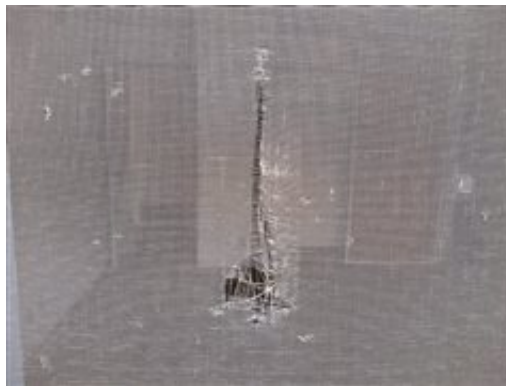
**Photo 20**

**59)** 🔧 One or more window screens were damaged or deteriorated. These window(s) may not provide ventilation during months when insects are active. Recommend replacing window screens as necessary.

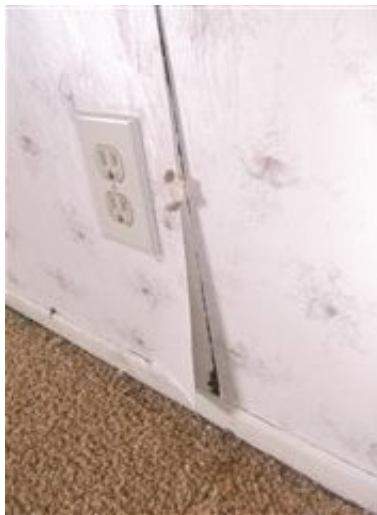
**Photo 157**

Interior room (s) wallpaper damaged in places.

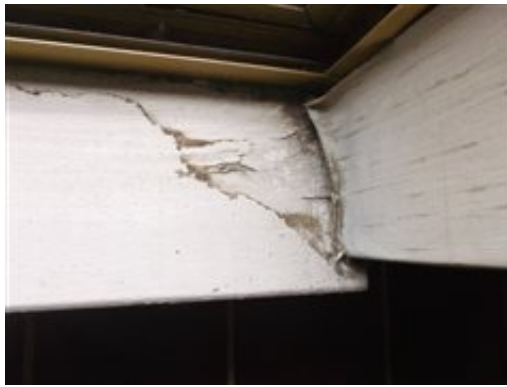
**Photo 151**

Condensation/ and or water penetration in sliding glass window at the dining area is evidence of seal failure. Have a qualified professional repair as necessary.

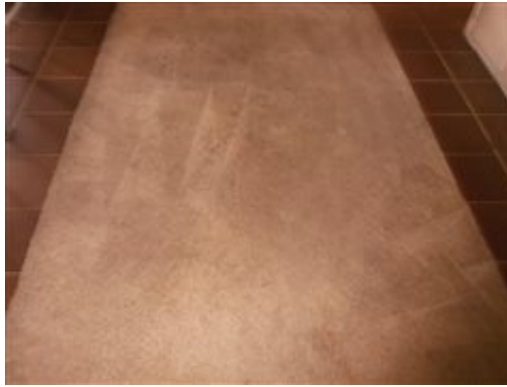
**Photo 142**

**62)** 🧹 Carpeting in one or more areas was significantly stained or soiled. Recommend having carpeting professionally cleaned as necessary.
